# Fremantle's Bridge Heritage

Peter M Palmer BSc. Hons., A.C.G.I., D.I.C., M.I.C.E., M.I.E.Aust.

**SUMMARY:** Historical records, contemporary drawings and photographs have been used to describe the eight bridges which have been built over the Swan River in Fremantle since 1863. The paper outlines the early history of the Swan River Settlement, including the events that led to the arrival of convicts in 1850, and describes how this enabled the first bridge at Fremantle to be built. It then shows how the construction of subsequent bridges was closely related to political and economic events in Western Australia and the development of Fremantle as the principal port for the State. The various bridges reflect developments in bridge technology since 1863 and the paper concludes that, while it has not been practical to preserve the structures themselves, their engineering heritage can be preserved by assembling and recording the available written and visual records.

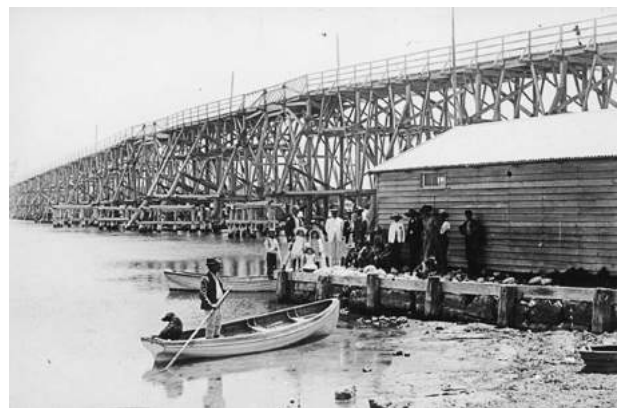
**Figure 3. High Level Bridge**  
(Courtesy Fremantle City Library)

Figure 3 is another view of the bridge which illustrates the enormous amount of timber used in the piers. The method of constructing the bridge in order to achieve the required height for navigation clearance was quite ingenious and is illustrated in Figures 4 to 8, which are

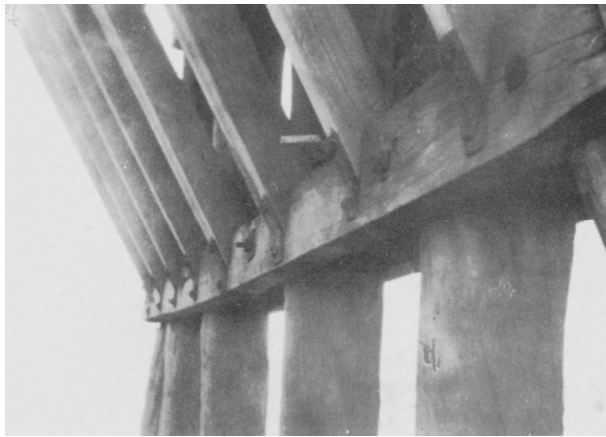
**Figure 7. Sloping Struts at Springing**  
(Courtesy of the Battye Library, Perth)

Except in the navigation spans the piles were also braced longitudinally between the capping beams at a level of 4.3 metres above high water level to provide more stability. A Close-up view of the sloping struts at their springing is shown in Figure 7.

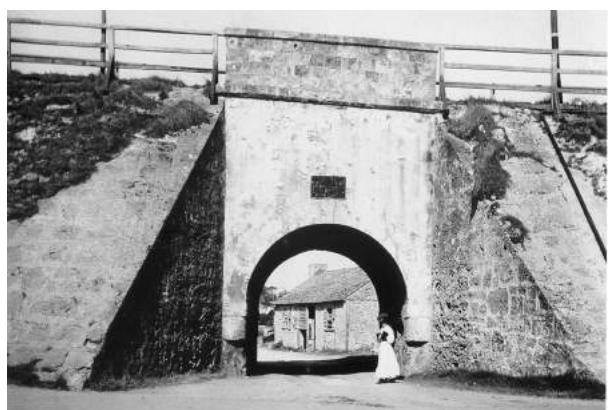
**Figure 10. Stone Arch under South Embankment**  
(Courtesy of the Battye Library, Perth)

The stone arch bridge under the southern approaches to the main timber bridge mentioned earlier is of interest as it has been identified by O'Connor as one of only two masonry arch bridges ever built in WA<sup>6</sup>. Figure 10 is a photograph of the arch which had a span of approximately 4.3 metres.

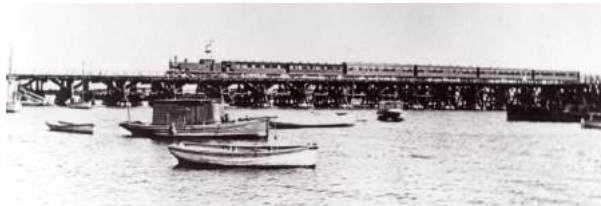
**Figure 11. 1880 Railway Bridge**  
(Courtesy Fremantle City Library)

The second bridge to be built in Fremantle carried a single track of the Fremantle to Guildford railway over the Swan River. Construction of the railway commenced in January 1879 and the railway was opened in March 1881. The bridge was built during 1880 and was located approximately 600 metres downstream from the High Level Bridge. It is illustrated in Figure 11 and had a length of 198 metres, made up of fifteen timber spans of 9.2 metres on the Fremantle side, which were supported by sloping struts at their third points, similar to the High Level Bridge, and four timber truss spans of 15.2 metres on the North Fremantle side.

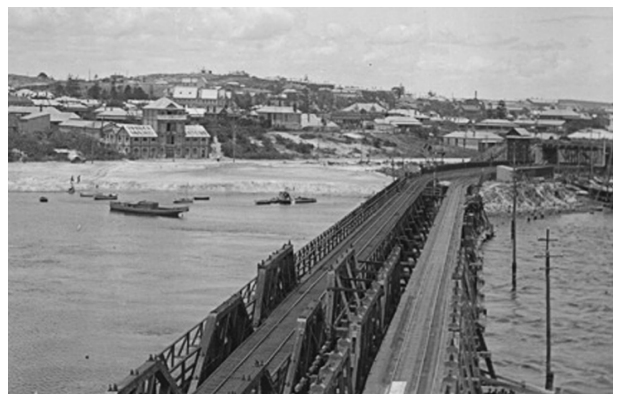
**Figure 13. Twin Railway Bridges**  
(Courtesy Fremantle City Library)

second railway bridge was built on the downstream side of the existing bridge in 1895 to carry stone from the quarry at Rocky Bay to the new South Mole being constructed at Arthur Head<sup>7</sup>. This was the third bridge to be built and subsequently provided a second rail track

over the river for the Fremantle to Guildford railway. The twin bridges are shown in Figure 13.

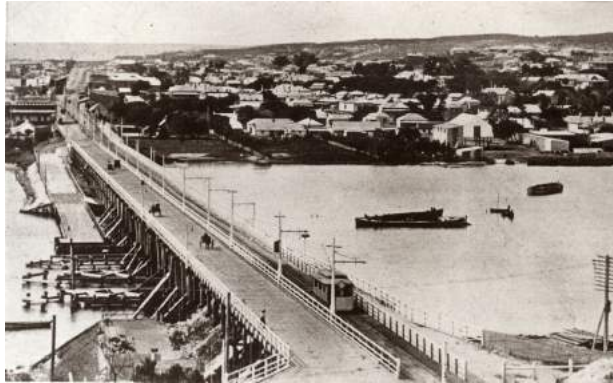
**Figure 17.** *Renovated High Level Bridge*  
(Courtesy Fremantle City Library)

The deck of the High Level Bridge was removed, the piles cut down to an appropriate level, and additional piles driven to widen the bridge to allow for both road traffic and trams.

The Renovated Bridge was opened on the 18<sup>th</sup> June 1909, after which the Low Level Bridge was closed and later demolished. Figure 17 is a photograph which shows the Renovated Bridge with a tram crossing it and the low level bridge being demolished. The bridge was 10.7 metres wide and included a 7 metre wide carriageway for two lanes of motor traffic and a 3.7 metre tramway. In addition there was a 1.2 metre wide footway. The main deck was supported by 15 sawn timber stringers and 2 more stringers were provided under the footway. Larger stringers were used under the tramway to support the heavier loading. The Queen Post timber trusses spanning the two 13.7 metre navigation spans in the earlier bridge were removed and replaced with large sawn timber stringers. Sloping timber struts were provided on all the spans to support each stringer at the third points. The renovations were so extensive that I consider this to be a new bridge which therefore ranks as the fifth bridge to be built.

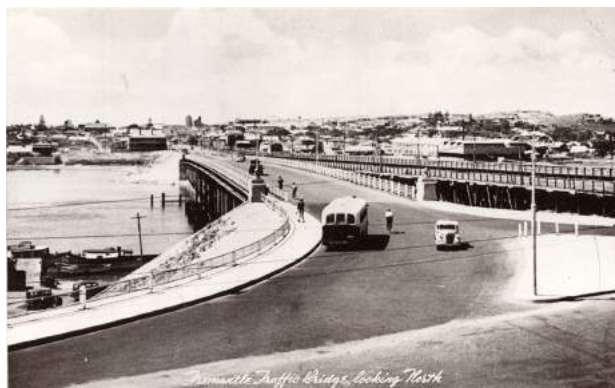
**Figure 19.** *Fremantle Traffic Bridge*  
(Courtesy Fremantle City Library)

The bridge has a total length of 205.5 metres, made up of one steel span of 12.2 metres over Beach Street, 22 timber spans of 6.1 metres plus three central navigation spans supported by steel girders, two of 21 metres and a central one of 17.1 metres. It was designed by the Main Roads Bridge Engineer, Mr E. W. Godfrey, and was the seventh bridge to be built in Fremantle.

Figure 19 is a photograph taken in the 1940's, looking towards North Fremantle, and shows the old Renovated High Level Bridge just upstream. When the new bridge was opened there was concern that Fremantle could be subject to bomb attacks and the old bridge was left standing for emergency use and was not finally demolished until 1947.

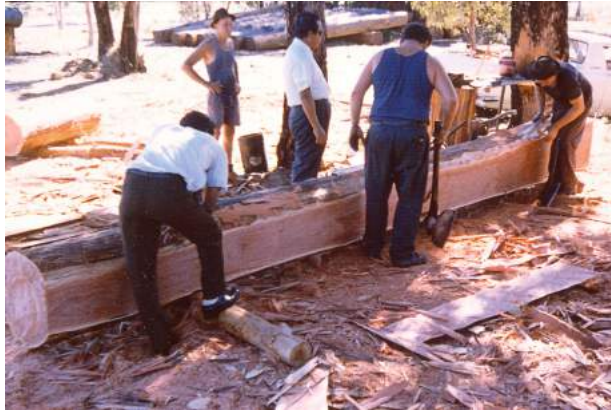
**Figure 22.** *Timber Stringers Being Shaped by Broadaxe*

The flat seatings on the timber corbels and stringers were shaped by hand using a broadaxe and this operation is shown in Figure 22.

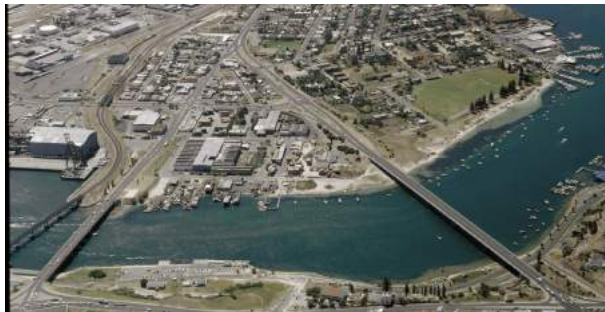
**Figure 23.** *Aerial View of Existing Bridges*  
(Courtesy of the Battye Library, Perth)

Figure 23 is an aerial photograph, taken in February 1975, which shows all three existing bridges in Fremantle, two of which have been built relatively recently. On the left is the present railway bridge and adjacent to this is the existing Traffic Bridge and on the right is Stirling Bridge.

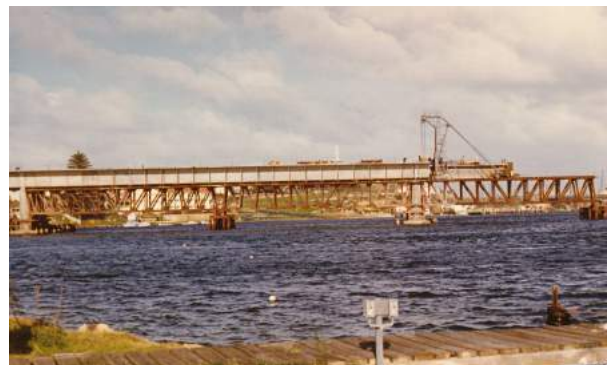
**Figure 25.** *Stirling Bridge during Construction*

The method used to construct the bridge is shown in Figure 25. The whole deck is made up of individual precast concrete units which were supported on temporary girders before being prestressed together into a continuous beam for each span. Hollow ducts had previously been cast into the individual precast concrete units and, when these had been assembled into a whole span, high strength steel cables were threaded through the ducts and prestressed with a jacking force of 350 tonnes then anchored at each end to permanently maintain the prestress force in the bridge.

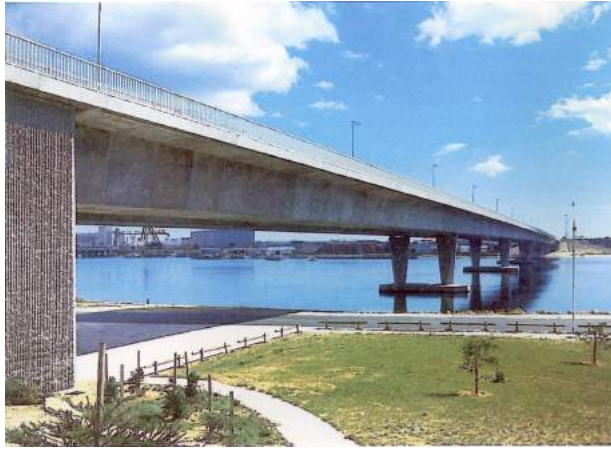
**Figure 26.** *Stirling Bridge*

Figure 26 shows the completed bridge, which was opened on the 17<sup>th</sup> May 1974 by the then Premier, Sir Charles Court. The bridge has six spans with a total length of 350 metres and the deck profile is not horizontal but rises 4.6 metres on a uniform curve from the north to the south abutment. The span lengths vary from 47m at the north abutment to 81m at the south abutment, with a corresponding increase in beam depth from 1.8m at the lower end to 3.4 metres at the higher end, in order to make the underside of the bridge appear more level with the river and enhance appearance of the bridge.
